ARCHEOLOGICAL INVESTIGATIONS AT THE LINCOLN HOME NATIONAL HISTORIC SITE, SPRINGFIELD, ILLINOIS

By
Floyd Mansberger

NORTHERN ILLINOIS UNIVERSITY
DEKALB, ILLINOIS

Prepared For The National Park Service
Midwest Archeological Center-Lincoln, Nebraska

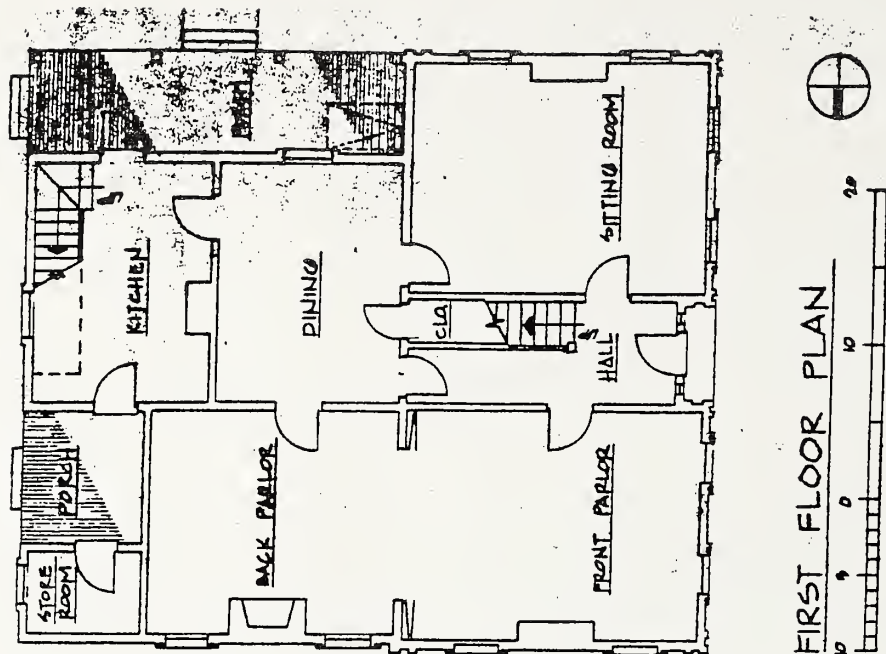
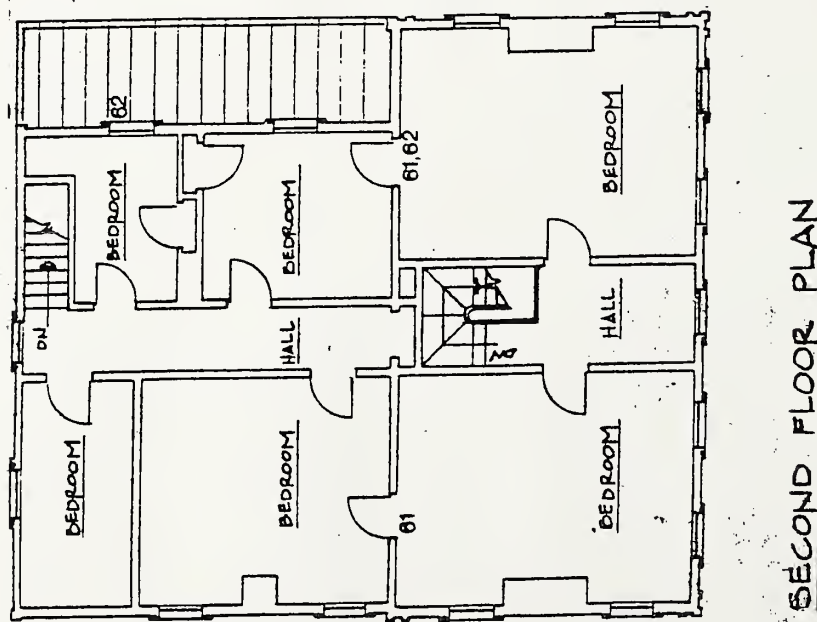
FIGURE 49. The Lincoln Home Floor Plans, Circa 1860 (from Ferry and Henderson 1981).

By the time Lincoln left for the White House, his home was a large two-story frame structure containing approximately 3,500 square feet of living space (Figure 49). The house had undergone at least two major alterations by the Lincoln family prior to this date.

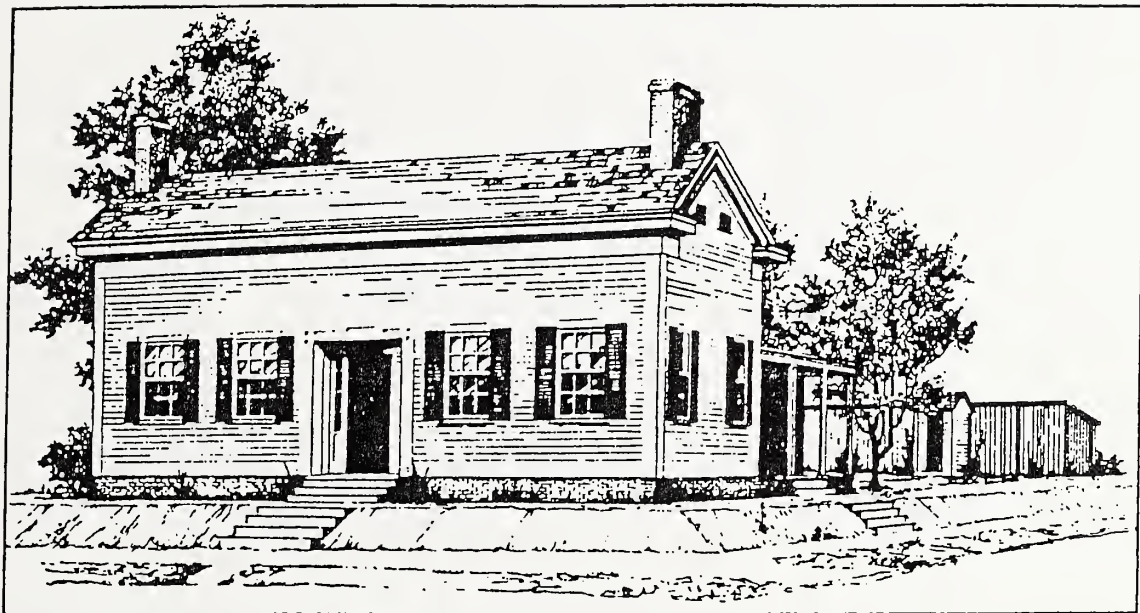
FIGURE 50. The Lincoln Home, Circa 1844 (Artist's Rendition From Hagen 1955).

The original house, as built by Charles Dresser, was a small 1-1/2 story Greek Revival cottage. Figure 50 is an artist's rendition of that early structure. The front part of the house originally contained downstairs two rooms and a stairwell -- similar to today's house. The upstairs of the front section contained garreted sleeping rooms. The back kitchen extension (or East Wing) of the Dresser home has always been a matter of interpretation. The most recent published interpretation, by Ferry and Henderson Architects (1981), illustrated an "L"-shaped kitchen extension, with the ell located perpendicular to and towards the north end of the main body of the house. Our excavations -- as well as recent structural investigations by Hahn and Associates (William Gran, personal communication) have shown this to be erroneous and have confirmed the existence of a 1-1/2 story kitchen extension (East Wing) which formed a "T"-shaped floor plan. The original 1-1/2 story structure, with its basement, contained approximately 2,950 square feet of living space.

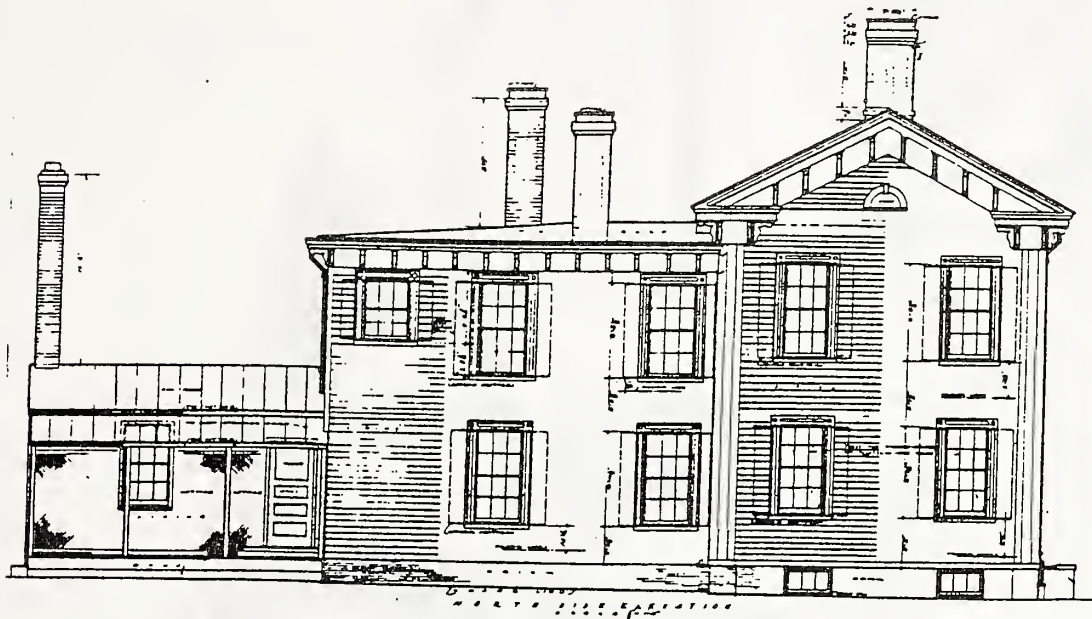
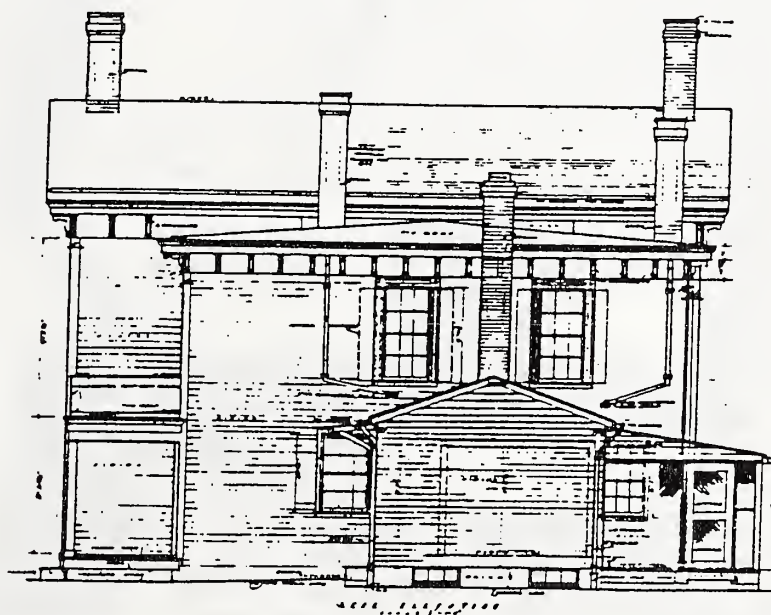
FIGURE 51. Lincoln Home Historic Drawing Illustrating the 1870's Kitchen (Courtesy of the National Park Service).

After Lincoln's death, the house was rented to several different families. From 1870 until 1880, the house was rented to the George Harlow family. During his occupation of the site, a back kitchen addition was added onto the house. Figures 51 and 52 illustrate this addition. This frame addition had a brick cellar with an exterior access stair, concrete floor, pump, and sink, and was used as a laundry room. The laundry room and kitchen were removed by the State of Illinois as part of the 1952-54 renovation of the Home. The brick cellar remains intact, buried in situ.

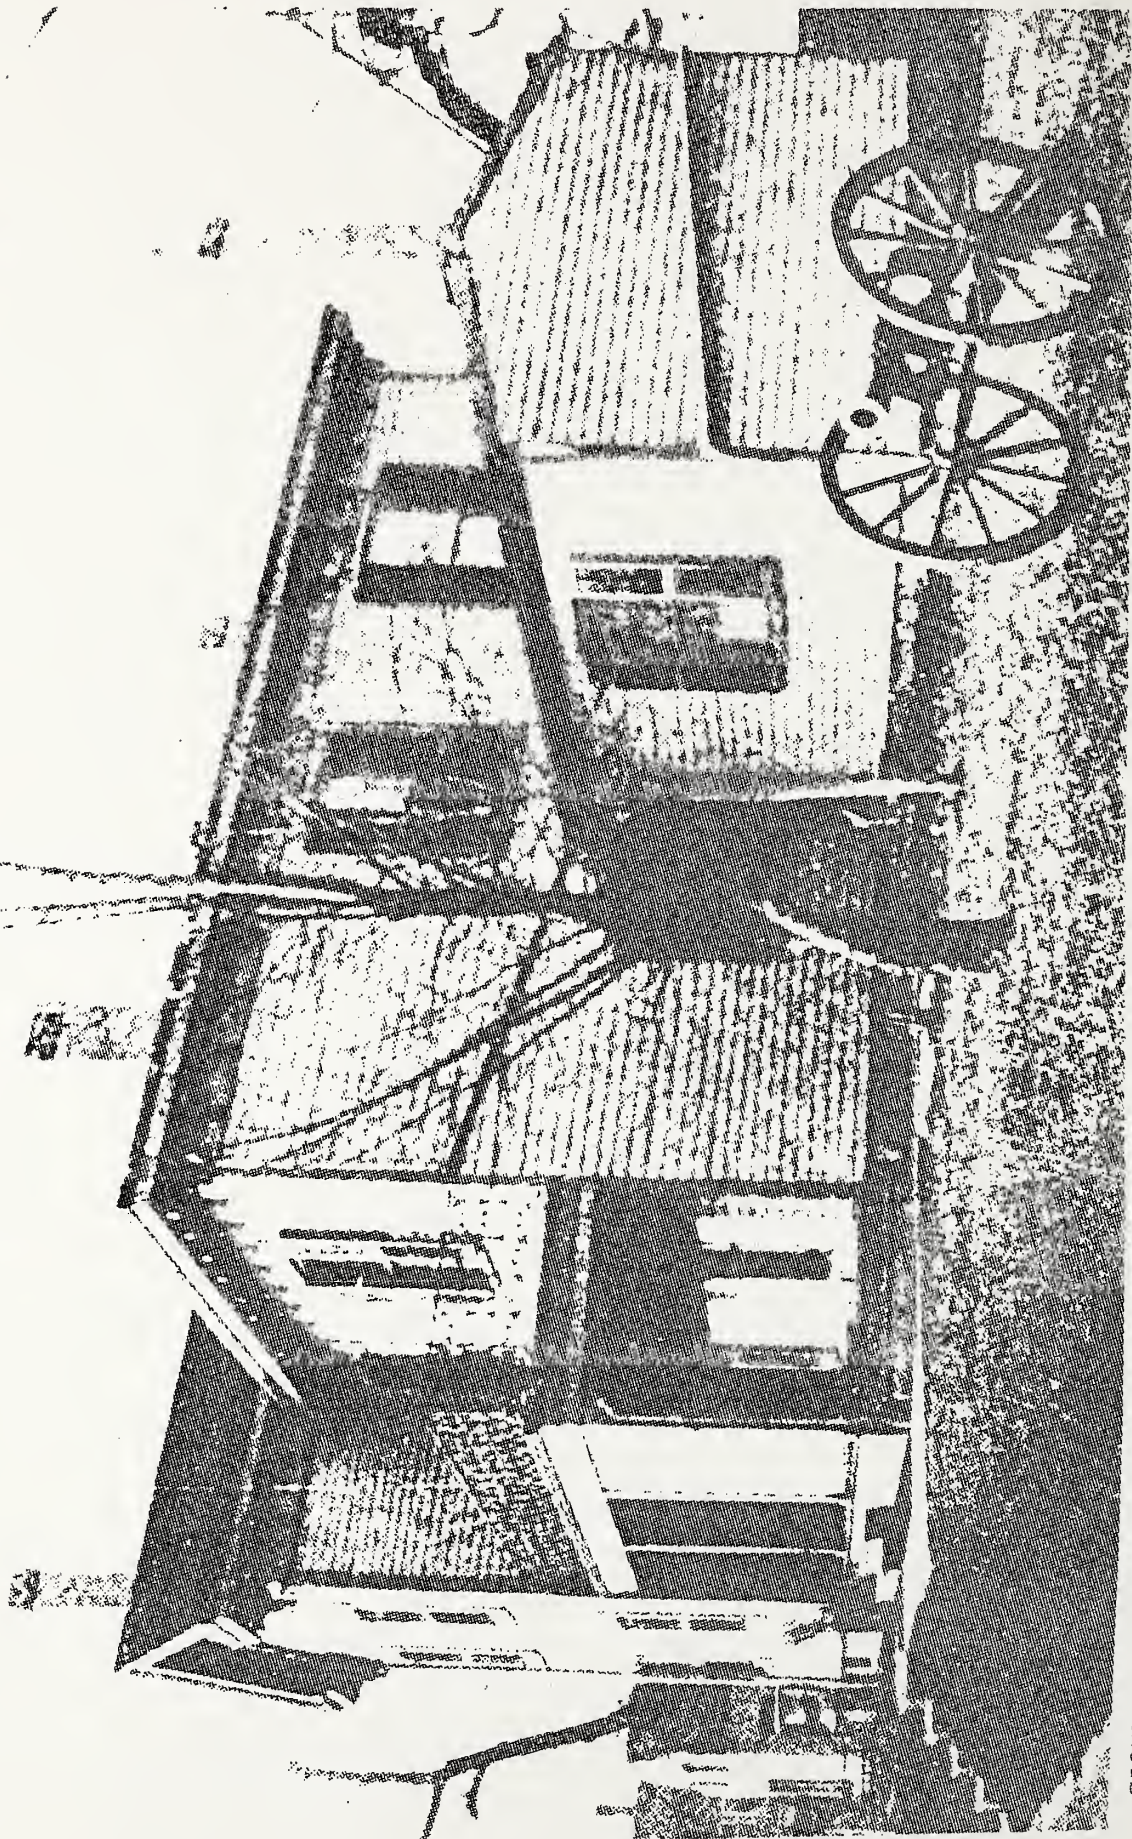
FIGURE 52. Photograph of the Lincoln Home, circa 1890 (Courtesy of the National Park Service).

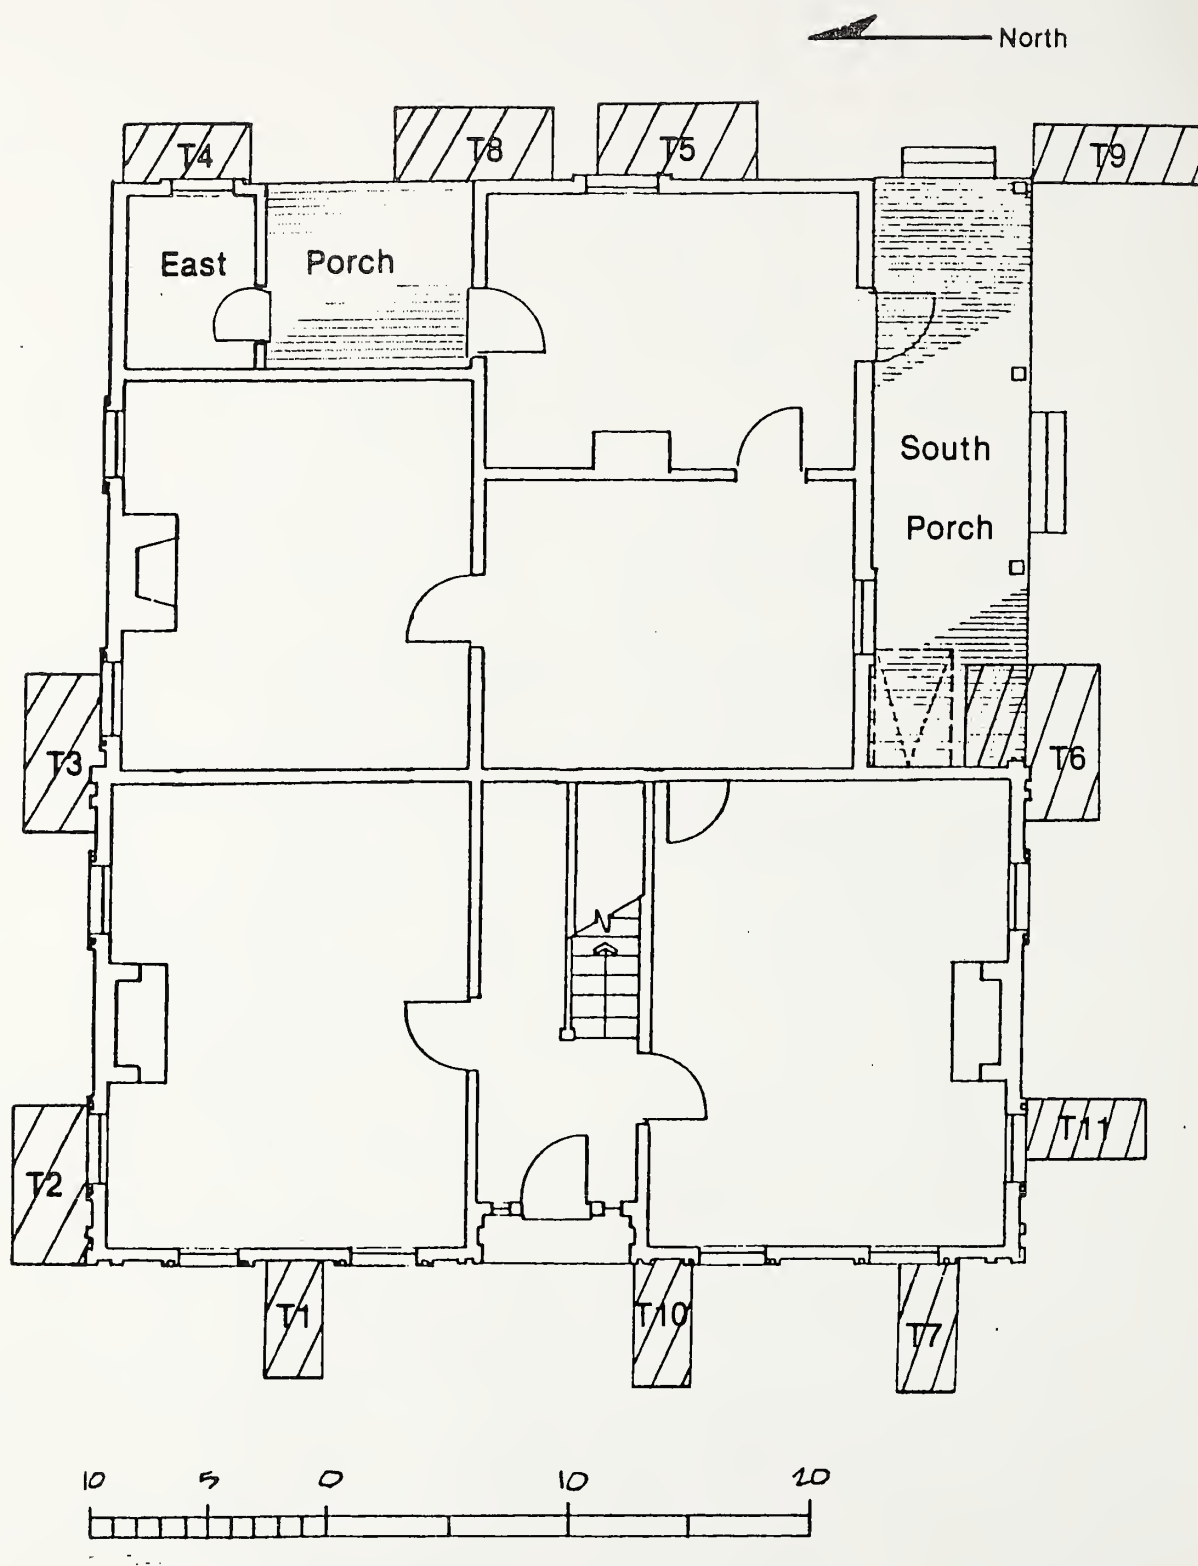
FIGURE 53. The Lincoln Site Base Map, 1985 Field Excavations.

Lincoln's Home, as well as artifacts -- or features -- dating from the 1839 to circa 1856 context. Figure 53 is the base map showing the relationship of the tests to the house and surroundings. Figure 54 shows the Lincoln Home Site Plan at the time of the excavations.

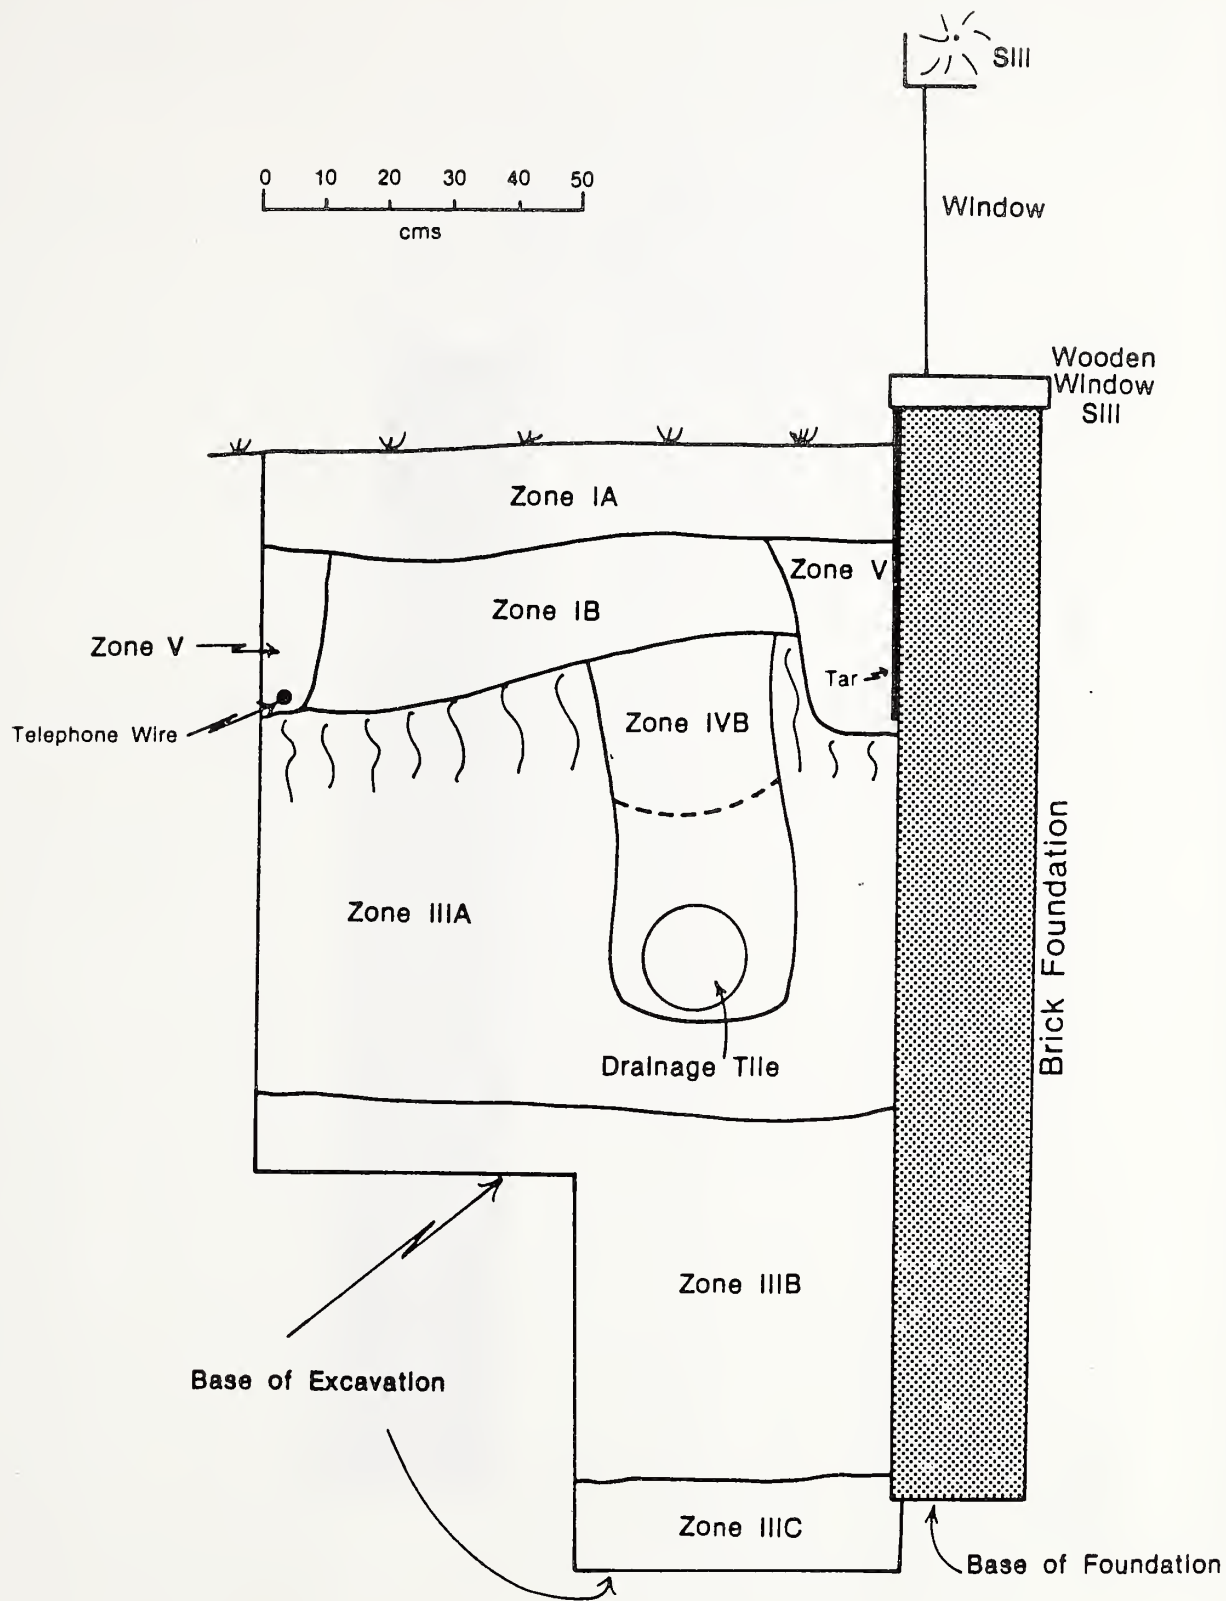
Test 2 (Figure 56)

FIGURE 56. Lincoln Site, Test 2, East Wall Profile.

Test 2 was a 1 x 2 meter test located along the north side -- towards the front -- of the house. It was excavated to a depth of 1.75m below the present ground surface. The foundation extended to a depth of 1.63m below surface; no spread footing was recognized. The top 30-45cm of fill had been disturbed by 20th-century tarring of the foundation, as well as by more recent buried telephone lines. Zone IIIA consists of a very dark grayish-brown (10YR 3/2) silt loam, which represents a well-developed A-horizon. Zone IIIB, a yellowish-brown (10YR 5/4) clay silt loam, represents an in situ developed B-horizon. Zone IIIC, a light olive brown (2.5YR 5/4) clayey silt, represents the pedological C-horizon. No builder's trench was recognized. Artifacts found in association with Zone III consisted of aqua container glass, machine cut nails and a single purple transfer printed whiteware sherd.

A mid-19th century stoneware drainage tile trench was dug into this original ground surface (Zone IVB). The location of the outlet for this drain is not known. It either went straight (west) onto 8th Street or turned a 90-degree corner and went onto Jackson Street. This drainage line is of mid-19th century origin and constructed of hand-turned drainage tile probably made locally (Figure 57). Similar tile were recovered from an

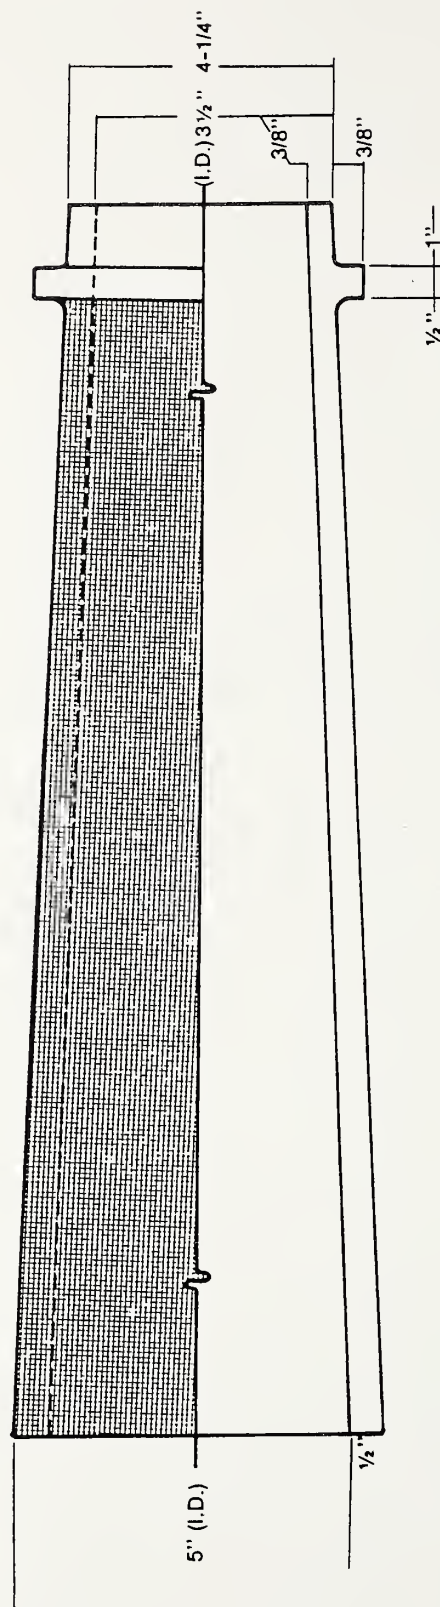
FIGURE 57. Lincoln Site, Mid-19th Century Stoneware Drainage Tile (Drawn by Fran Krupka, National Park Service).

1840's context in west-central Illinois at the Mitchell House Site (Mansberger 1981). It is suspected that this drainage tile dates from the 1848-1853 remodeling of the Lincoln Home.

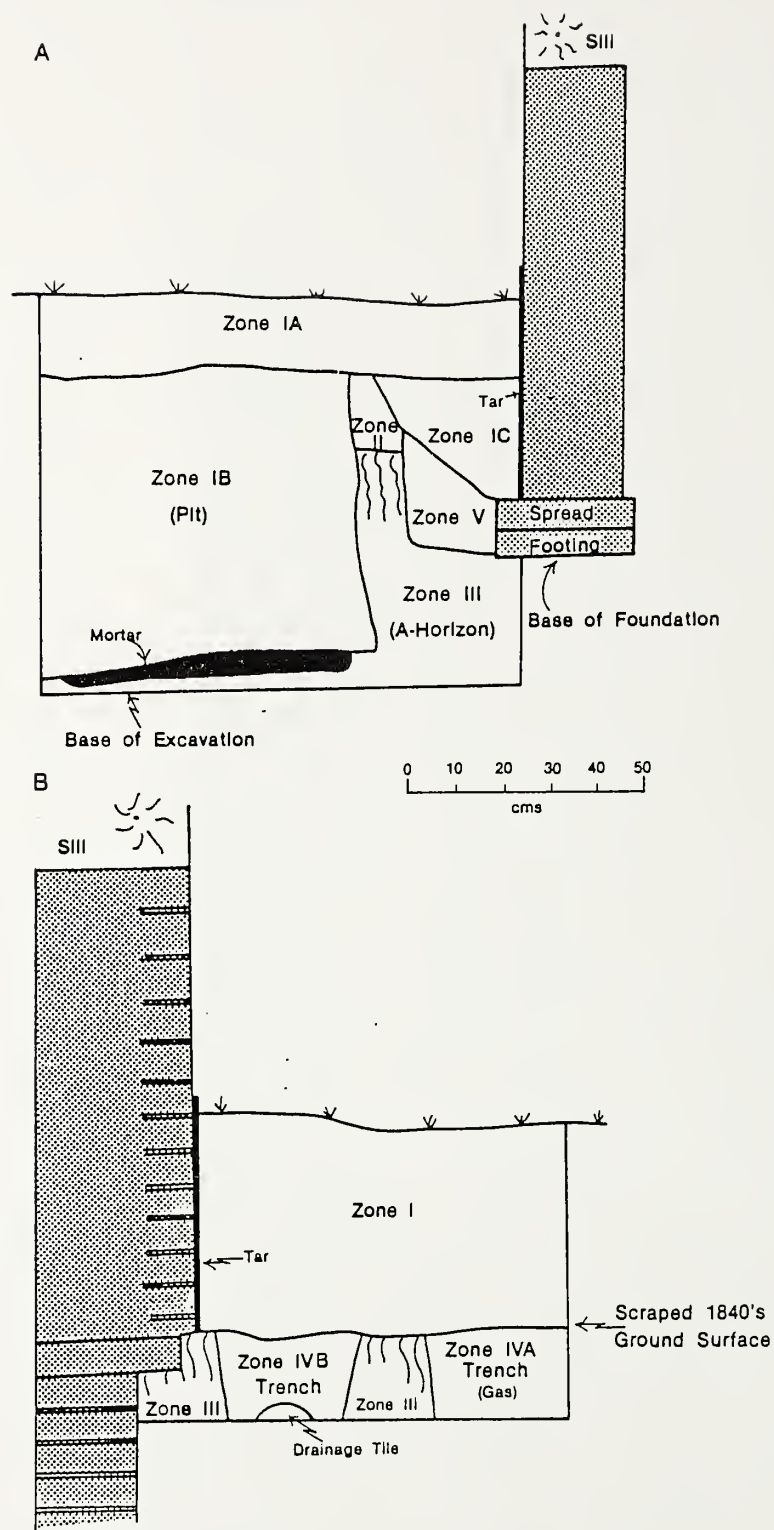
Test 3 (Figure 58)

FIGURE 58. Lincoln Site, Test 3, East and West Wall Profiles.

Test 3 was located along the north side of the house, associated with the back kitchen extension (East Wing). It was a shallow excavation unit that had been disturbed by drainage lines, gas lines, water lines, and recent (1954) construction of the furnace room and its bulkhead entrance. Figure 58B illustrates the base of the corbelled pilaster. Figure 58A illustrates the foundation of the north wall of the back addition (East Wing). This wall extends to a depth of 57cm below the present ground surface (103cm below the base of the sill). A double-course spread footing was found. Of particular interest is the remnant of an A-horizon (Zone III) with a well-defined builder's trench (Zone V). Both features -- the spread footing and the builders trench -- are in contrast to the original house construction techniques. Zone IC represents an episode of foundation waterproofing by the application of tar. Zone IB is a 1950's disturbance associated with the construction of the cellar entrance and basement furnace room. The excavation of Test 3 clearly showed how the back portions of the existing north wall of the house butts up to the front (west) portion of the foundation wall.

The excavation of this test also uncovered the original southeast corner of the Dresser-period back kitchen extension. Below grade, a clear distinction between two portions of the wall indicated where a shallow brick wall with a two-course spread footing butted against a deeper constructed foundation with no spread footing. The younger wall extended to a depth of only 15cm below grade. The earlier wall -- without its spread footing -- was similar to the original Lincoln Home foundation recognized in Tests 1 and 2. The younger wall -- with its spread footing is similar in construction to the wall recognized in Test 3 (Figure 58A).

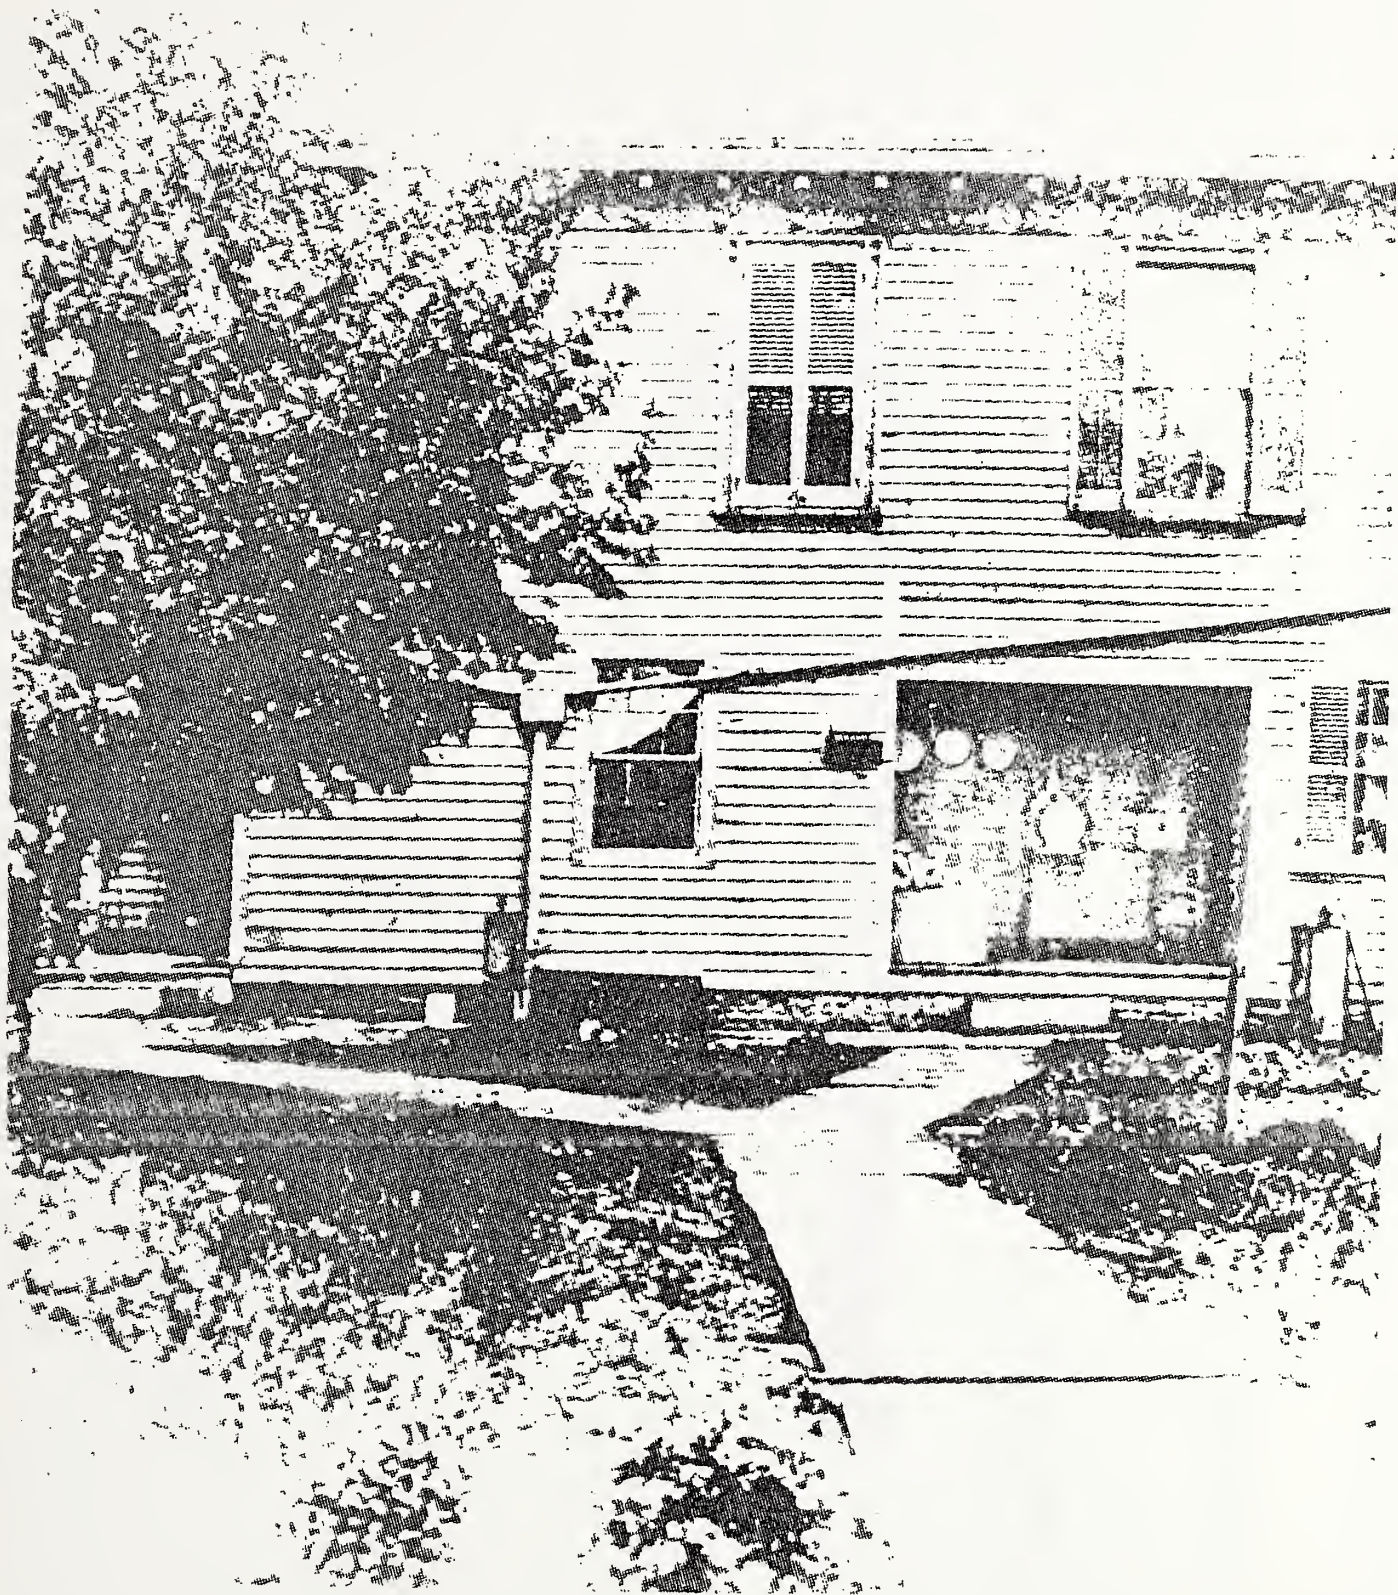
FIGURE 59. The Lincoln Home; Ridgeway Glover Stereopticon (1865; Courtesy of the Illinois Historic Preservation Agency).

Test 5 was located along the east wall of the house. From an inspection of the Ridgeway Glover Stereopticon (Figure 59) of the back of the Lincoln House (1865), it became clear that the gutter downspout ran directly into the ground and, more importantly, that the pumps were positioned very near to the house wall -- not several feet out from the wall, where they are currently positioned. Test 5 was excavated in hopes of locating the remains of a cistern that would have been associated with the southernmost 1860's pump.

On the contrary, a narrow builder's trench cuts through the well fill and suggests the well was filled by the time of Harlow's 1870's construction. Also, the 1860's Ridgeway Glover stereopticon (Figure 59) illustrates a second well outside the East Porch. It seems clear that the well found beneath the East Porch was filled during the period 1849 to 1853.

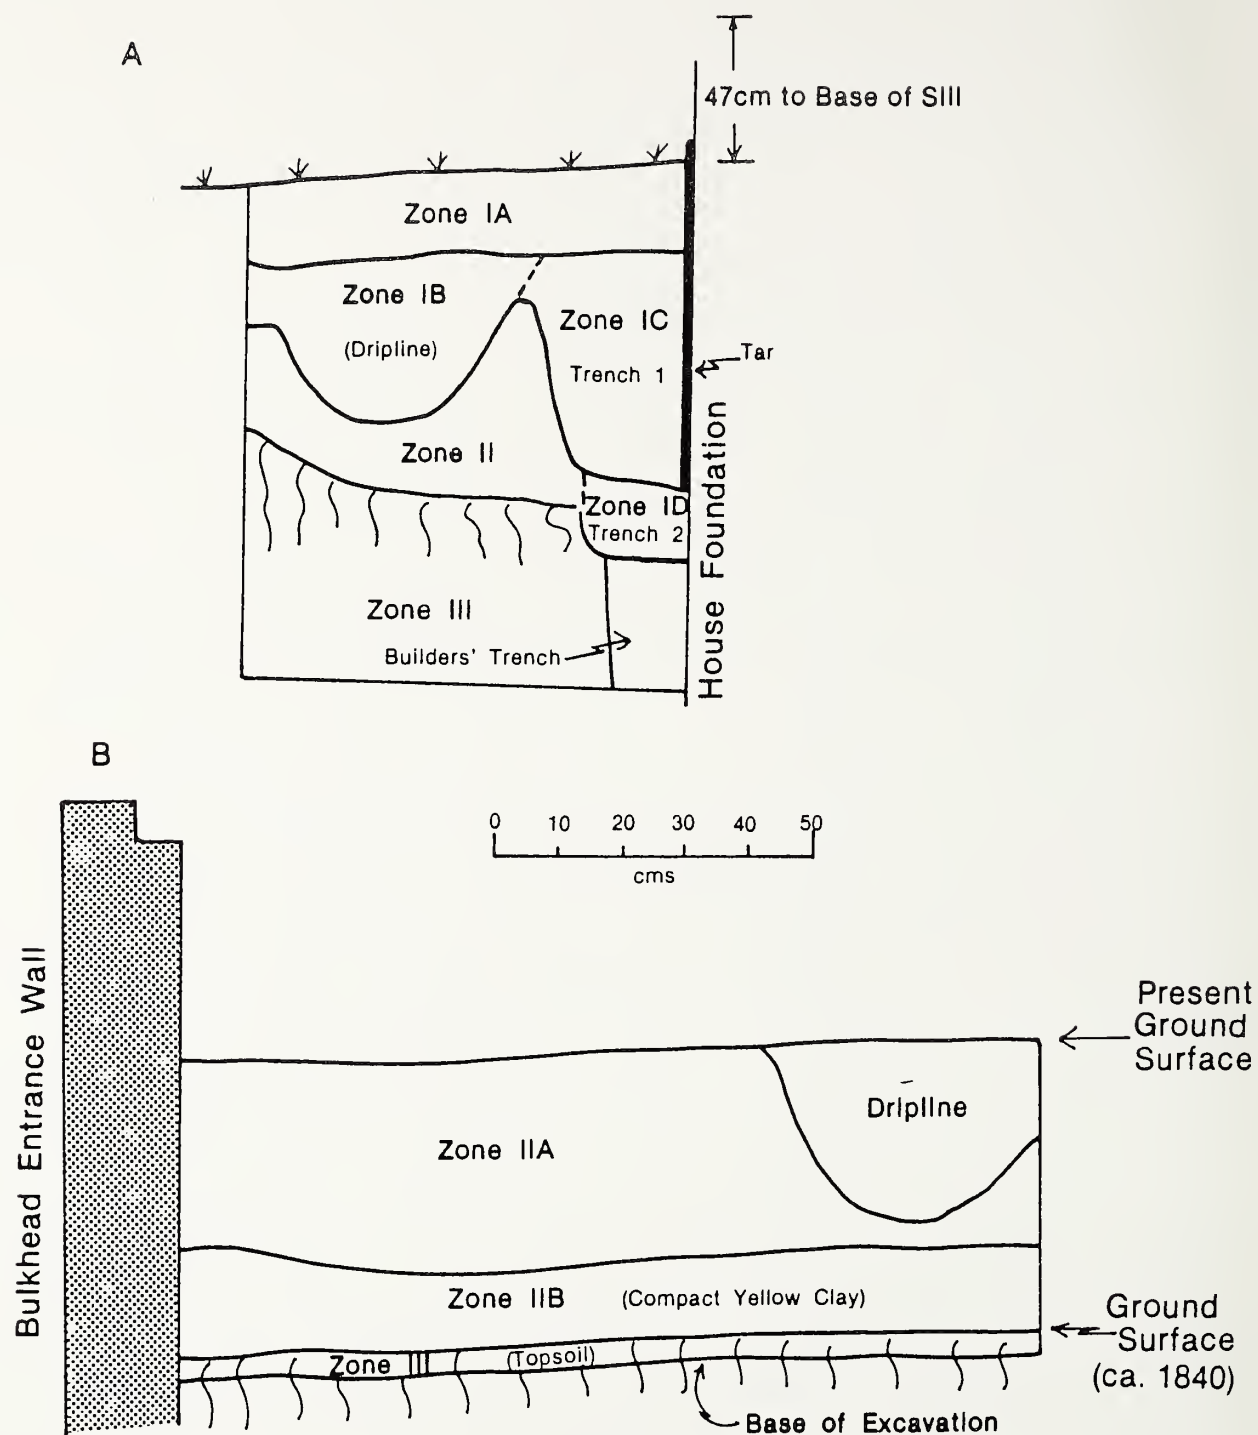
Test 6 (Figure 61, a and b)

FIGURE 61. Lincoln Site, Test 6, Profiles.
A. West Wall Profile
B. East Wall Profile

Test 6 was an L-shaped test excavated at the southeast corner of the main house block. It was excavated in hopes of determining the relationship between the south porch piers and the house foundation. The test was excavated to a depth of 80cm below the present ground surface. Similar stratigraphic zones as recognized in Test 1 were recognized in Test 6. Zone I consisted of the most recent 20th-century fill; evidence of a drip line and a trench for foundation tarring were recognized (Zone IC). Zone III consists of the undisturbed A-horizon. A narrow builder's trench was recognized in Test 6.

The east wall profile (Figure 61b) of Test 6 -- which extended beneath the porch, exhibited the best profile at the site illustrating the character of the 19th-century fill deposits. Zone IIA was a mixed fill zone with a well-developed drip line. Zone IIB is a compact yellow clay 15cm thick, which rests directly on top of the original ground surface. Both fills probably date from the original construction of the house. Beneath the south porch, just a few feet from this test, a brick walk dating from the original house construction rests directly on top of Zone IIA. Few artifacts -- except for a blue transfer print cup fragment, aqua container and flat glass fragments and machine cut nails were found associated with Zone II.

The brick pier at this location -- with its spread footing -- was butted to the original house foundation.

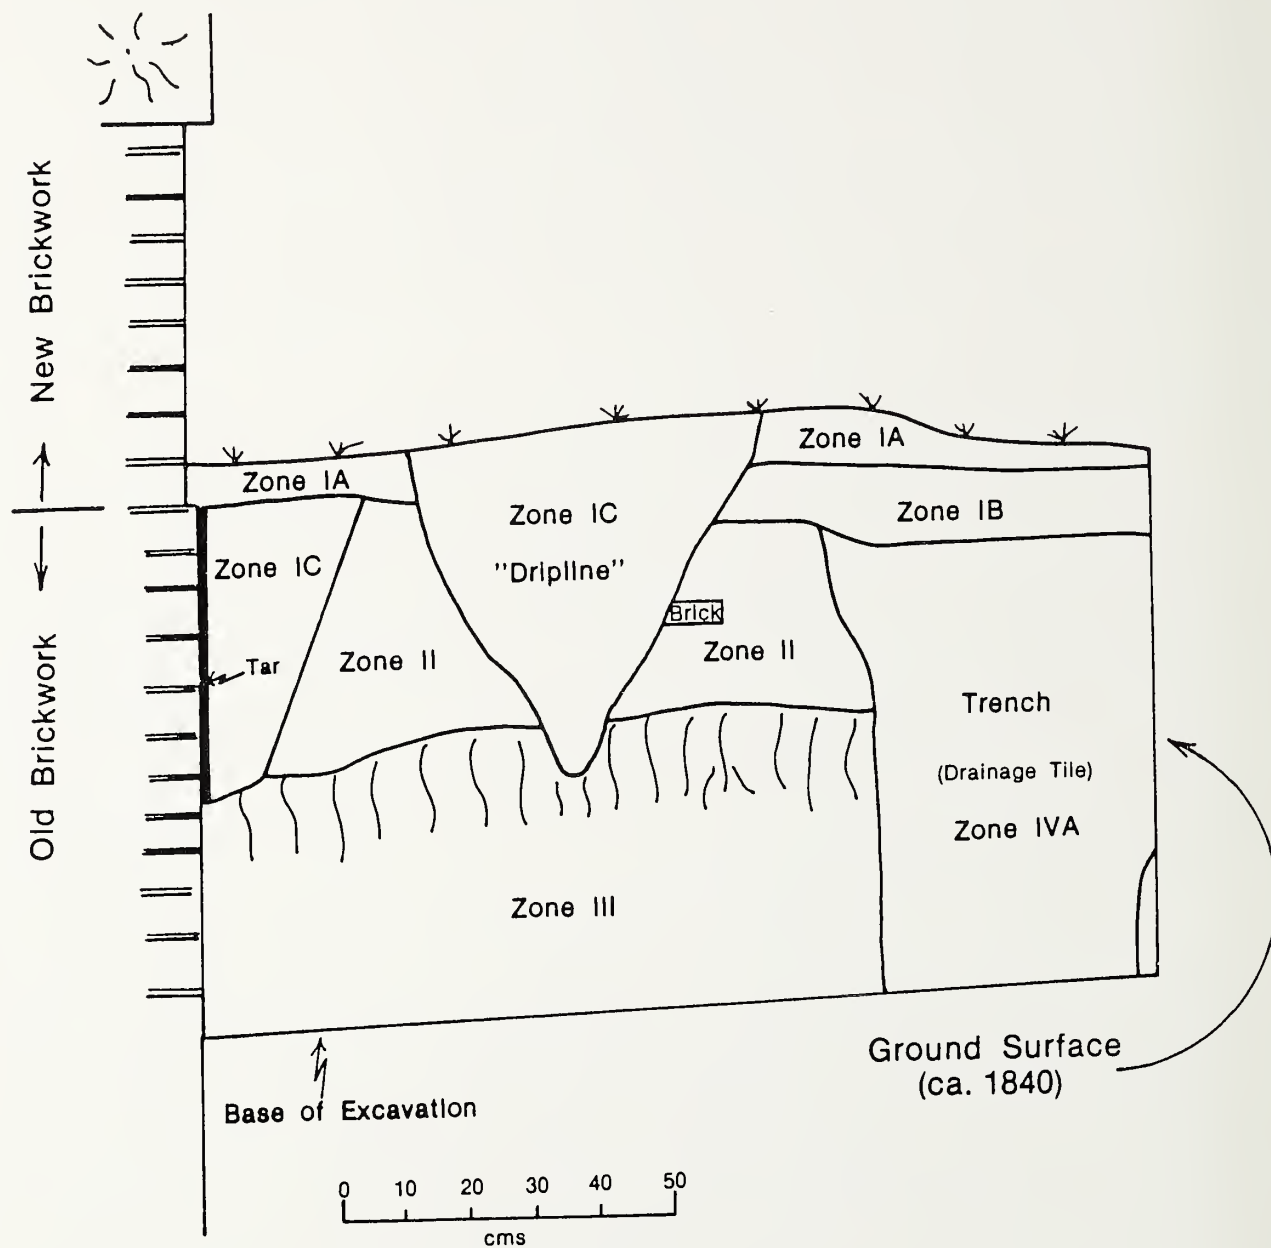
Test 7 (Figure 62)

FIGURE 62. Lincoln Site, Test 7, North Wall Profile.

Test 7 was excavated along the west wall of the house, near the southwest corner of the structure. It was excavated to a depth of 90cm below surface. Approximately 40-45cm of fill rested on top of the old ground surface. Evidence of tarring of the foundation, a drip line, and a trench that no doubt held a drainage line were all found. It was in Test 7 that it was first noticed that the top 9 courses of foundation brickwork were relatively new, having been replaced sometime in the 20th-century. This had been difficult to notice, due to the numerous coats of paint and tar that had been applied to the foundation. These bricks, hard-fired and machine-made, were very different from the soft-mud hand-made originals. Artifact density was low in Test 7; the only diagnostic artifact found in association with Zone II was fragments of a hand blown glass handle.

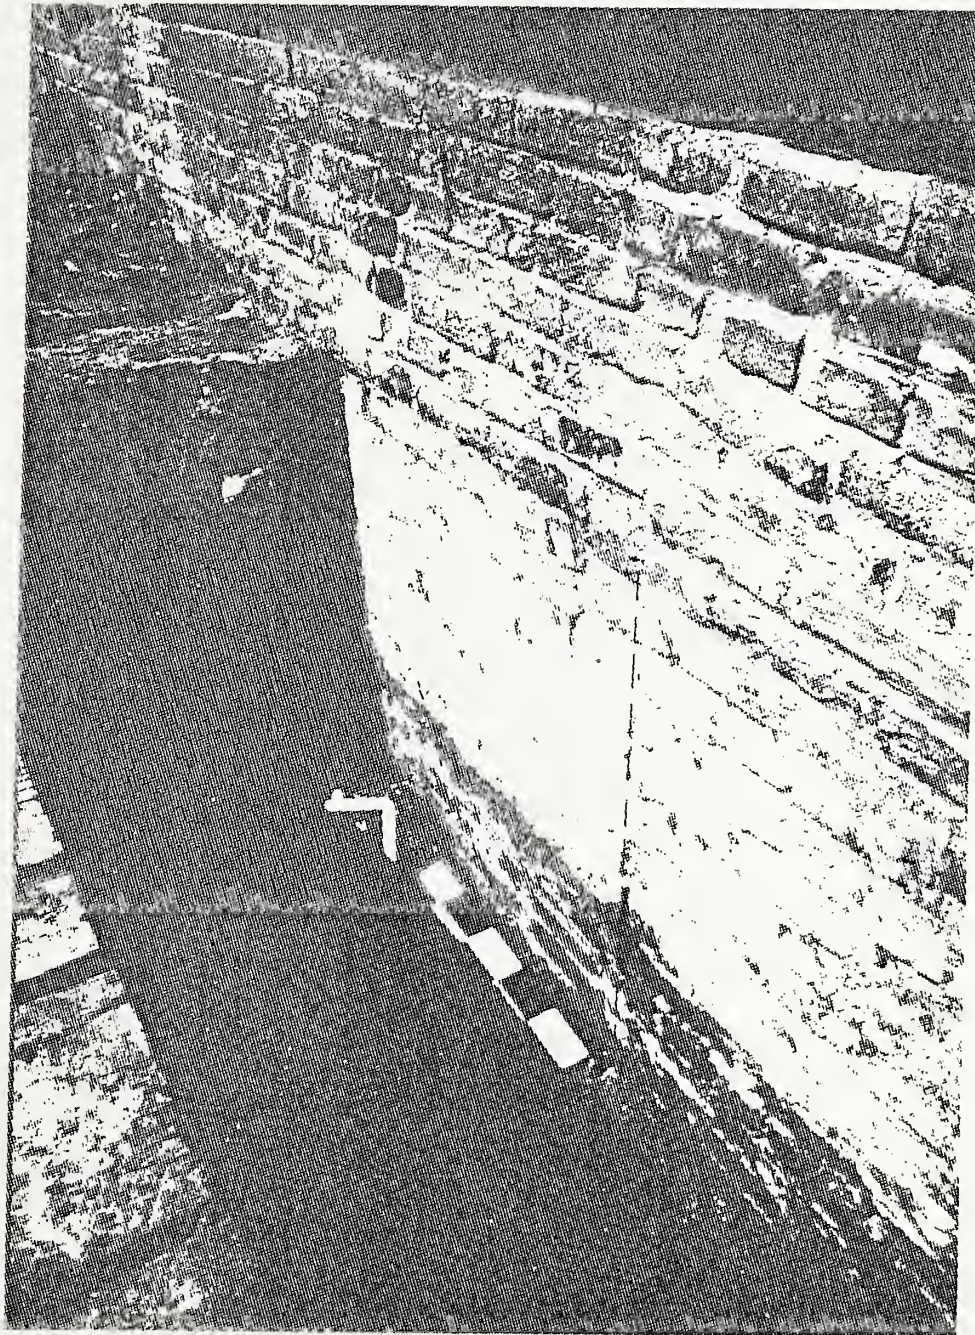
FIGURE 63. Lincoln Site, Test 8, Photograph of Foundation Wall Illustrating Circa 1848-53 Wall Butted onto Original Corner of Kitchen Wing Foundation.

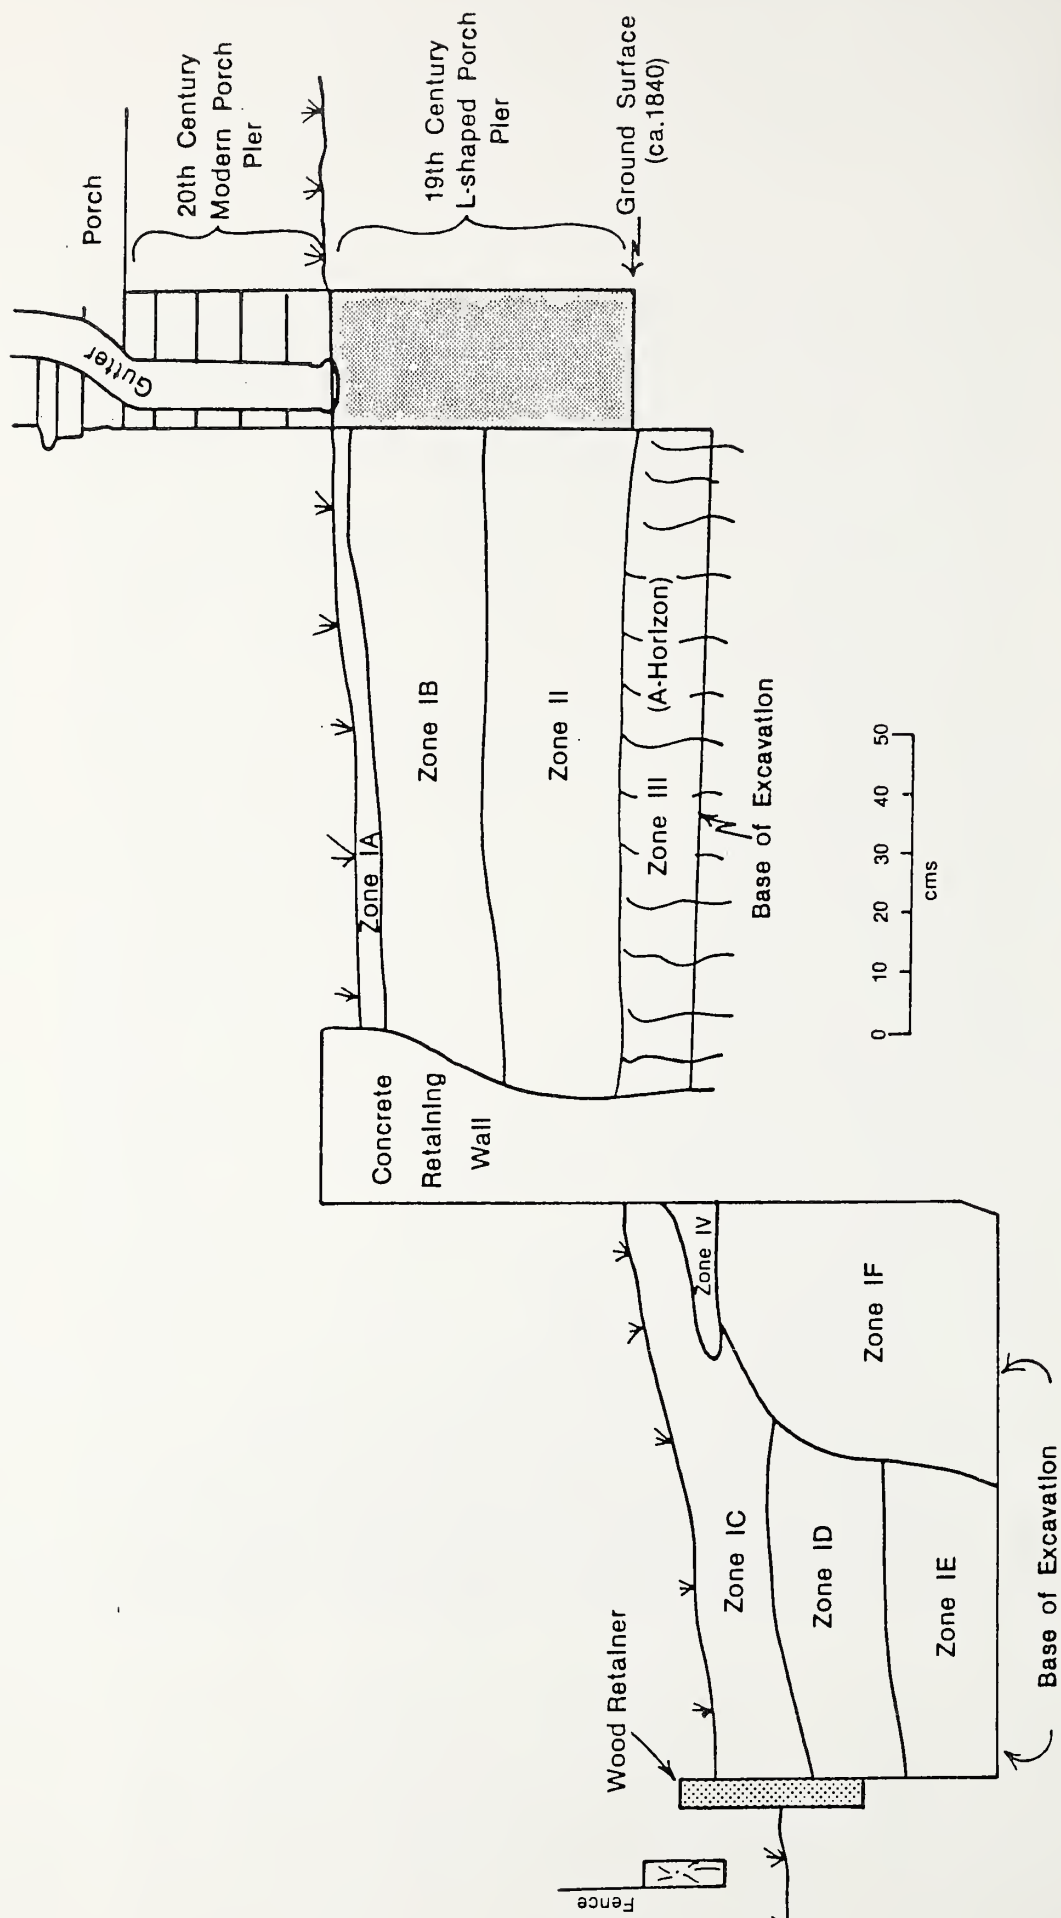
FIGURE 64. Lincoln Site, Test 9, West Wall Profile.

Test 9 was located at the southeast corner of the Lincoln House. It was positioned perpendicular to the south porch in such a manner as to create a profile from the porch pier through the concrete retaining wall near the porch to the wooden fence along the sidewalk. Test 9A represents the upper terrace, while Test 9B represents the lower terrace (Figure 64).

The upper terrace was the least disturbed. The old ground surface was located 40-45cm below the present surface. The original "L"-shaped porch pier (circa 1849-53) rested directly on top of the undisturbed topsoil (Figure 64). Variegated silt loams and yellowish-brown clays were piled around the pier. Twentieth century materials were found associated with Zones IA and IB. Except for a single clear glazed redware sherd -- no diagnostic artifacts were found associated with Zone II. Near the present ground surface, a 20th-century square pier rested directly on top of the older one. The later pier which rested off-center and unsupported by the earlier had settled drastically to one side (Figure 65).
